Experimental Assessment of Progressive Collapse of Reinforced Concrete Beam-Column Assemblages

Keywords: Experimental Assessment; Progressive Collapse; Reinforced Concrete; Beam-Column Assemblages.

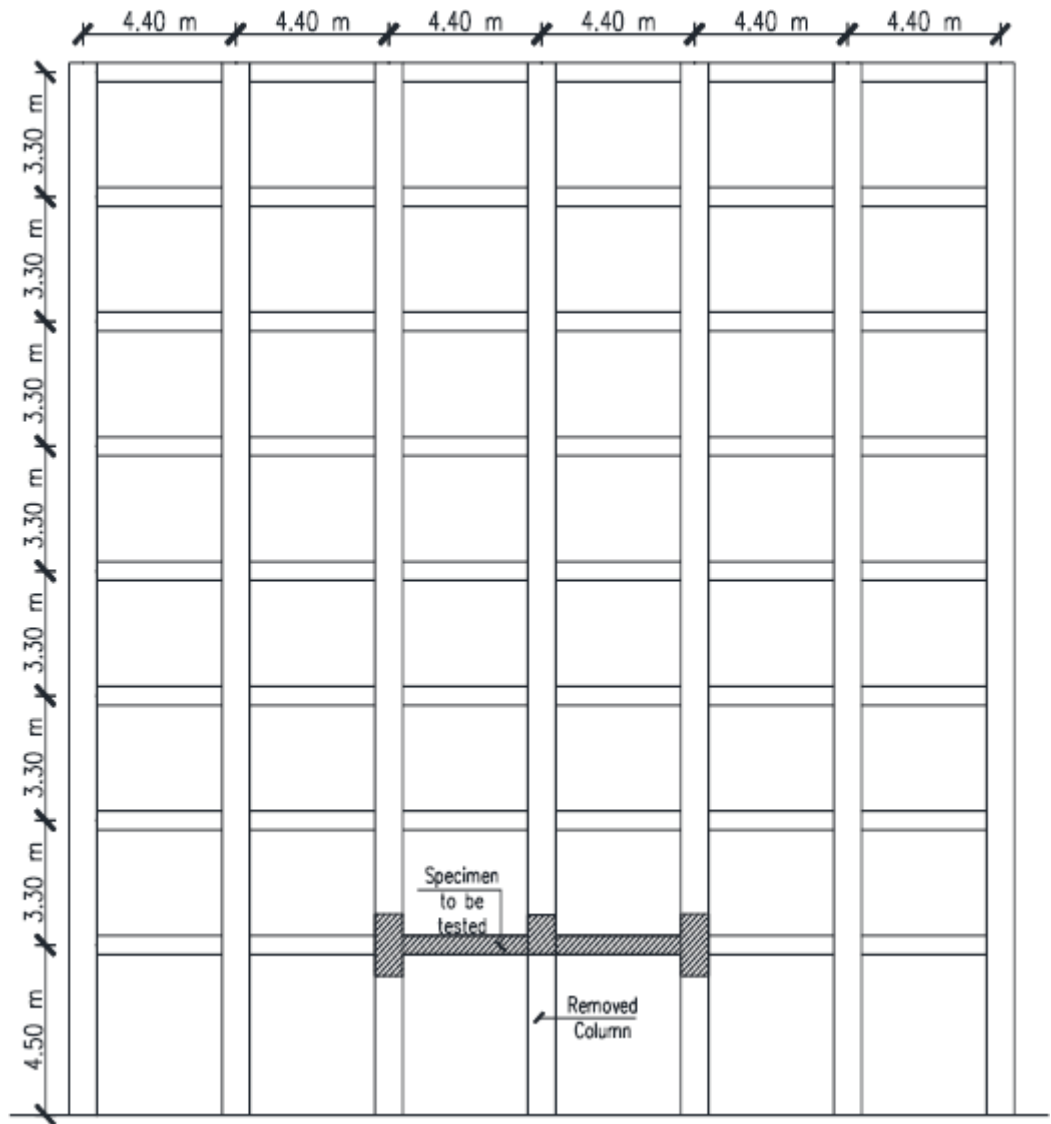
Figure 1: Commercial building elevation.

In order to study the effect of progressive collapse on beam-column assemblages, an interior column was removed. After the elimination of the central column as presented in Fig. 1, the shaded segment of the interior frame became the most critical part in the entire building due to

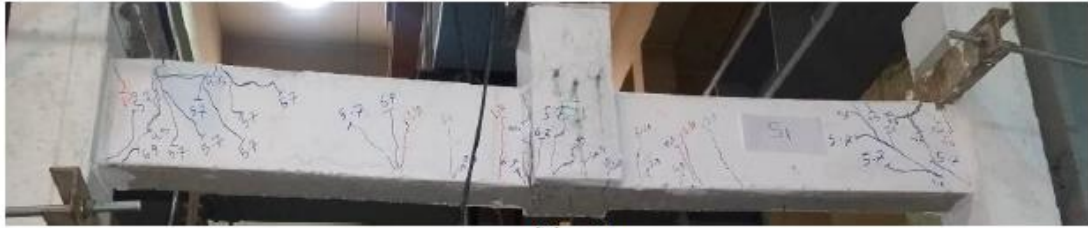
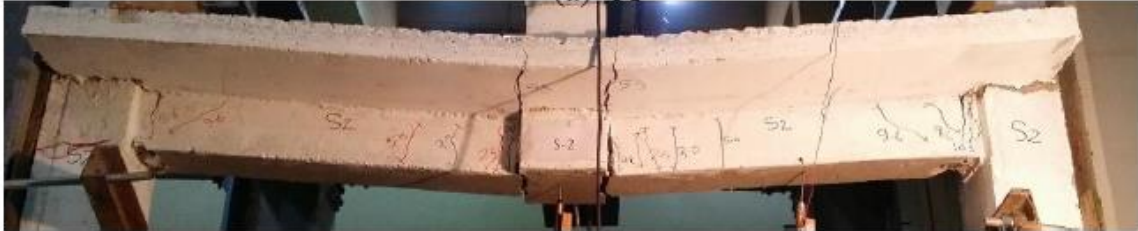
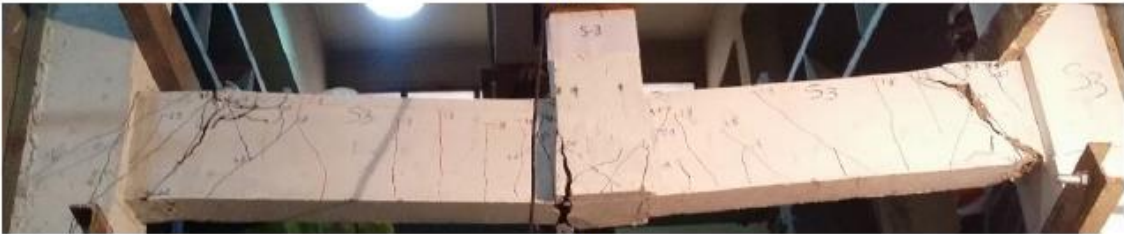
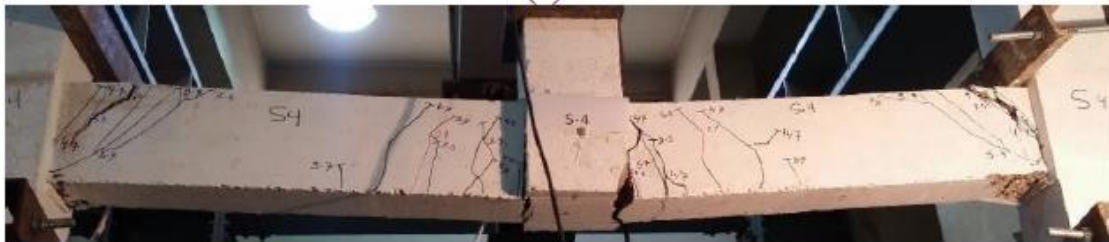
Figure 6: Crack patterns for non-seismic detailing of specimens at the peak of the compressive arch action.

The cracking patterns for non-seismic assemblages are shown in Fig. 6 at the peak of the compression arch action, and in Fig. 7 at failure. For specimen S1, applying vertical displacement to the interior column generates flexural cracking through the compression arch action stage. The first crack occurred near the interior column at a load of 12.54 kN corresponding to 1.87 mm vertical displacement. Inclined cracks at the beam connection with the exterior columns are developed at a load level of 45.25kN with 5.86 mm deflection. With further increasing load, more cracks continued to arise while the previous ones propagated vertically toward the compression zones. After reaching the peak load of 69.57 kN, it was recorded that concrete crushing occurred in the zones of the beam assemblage subjected to excessive compression besides the interior column and at the bottom of the beams at both ends. When the vertical deflection was 65.12 mm, the vertical load began to ascend for the second time and this was credited to the catenary action developing in the beams. Also, the cracks were distrusted all over the beam length. Finally, at the collapse of specimen S1, the beam deflection dramatically increased to 96.07 mm and the top reinforcement ruptured closest to the exterior column.

To study the effect of existence concrete flanges on the behavior of the non-seismic specimens, the beam column assemblage of specimen S2 is considered. As shown in Fig^s. 6.b and 7.b, the opening crack appeared at a load of 26.56 kN close to the interior column stub relating to 2.51 mm vertical deflection. As the vertical deflection increased to 9.66 mm; corresponding to vertical loading of 51.22 kN, more flexural cracks were formed in the beam span adjacent to the interior column. Inclined cracks at the beam-column joints at the exterior columns relating to a load level of 71.21 kN with 13.94 mm deflection were developed. Concrete crushing at the bottom of the

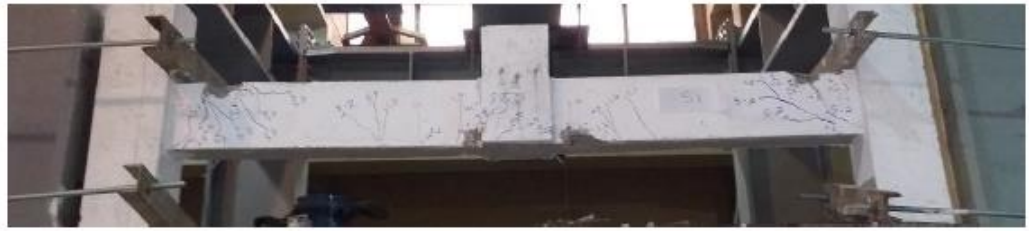
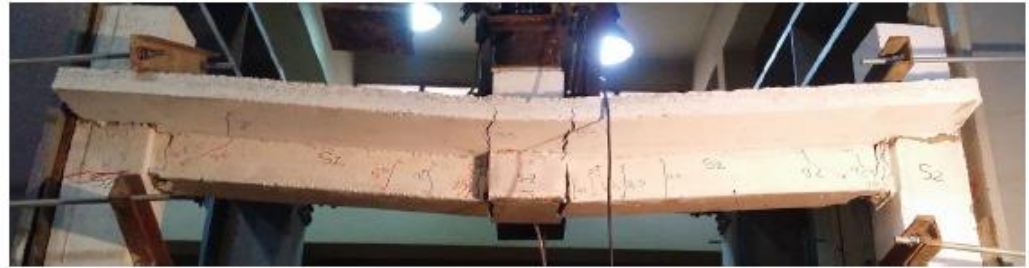
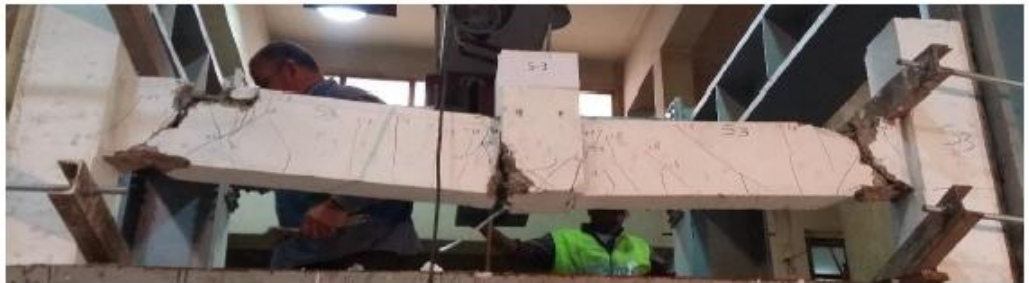
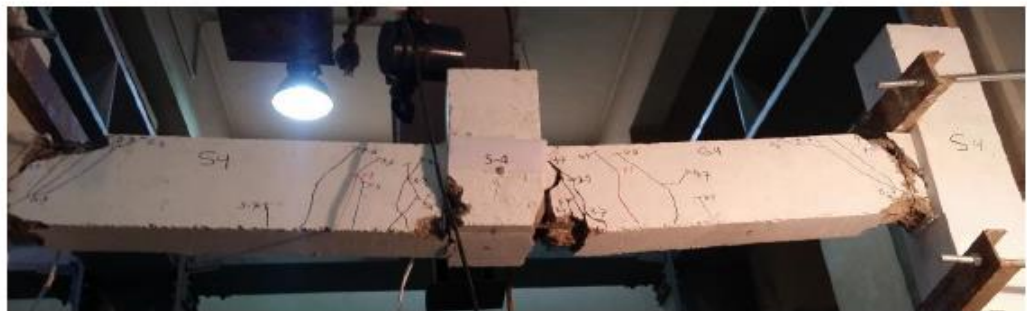
Figure 7: Crack patterns for non-seismic detailing of specimens at the peak of the compressive arch action.

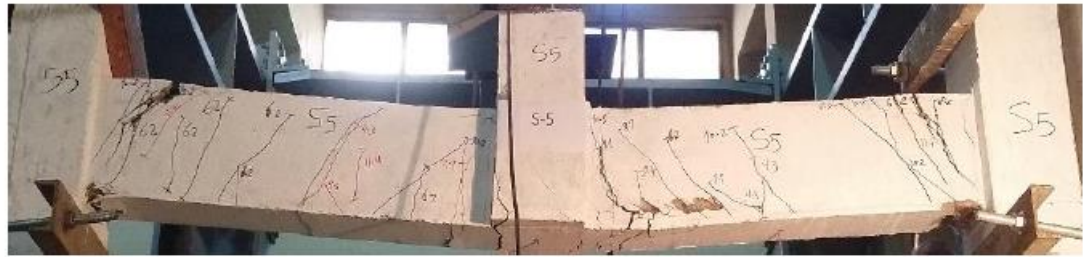
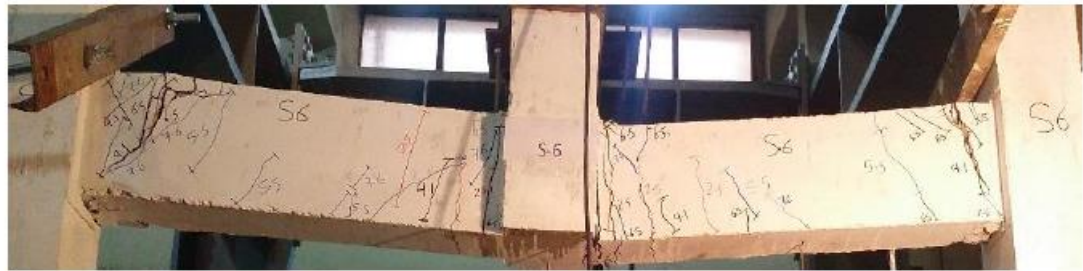
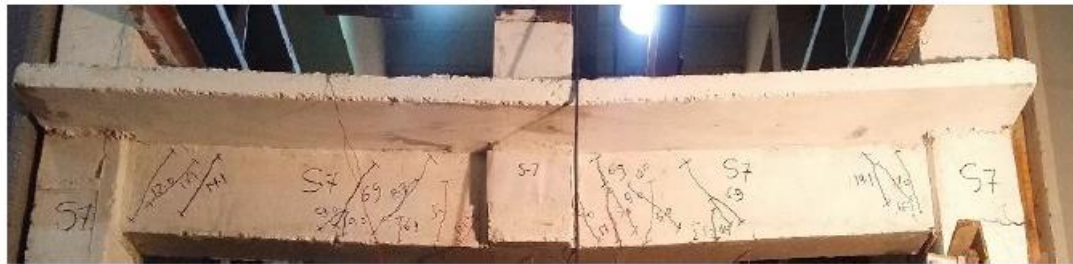
Figure 8: Crack Patterns for seismic specimens at the peak of the compressive arch action.

For the seismic specimens, there were no noticeable shear cracks developed in the beams during the test because of seismic detailing with much higher stirrups ratios in the plastic hinge zones. However, more severe flexural cracks appeared along the beam span compared to non-seismic specimens. Cracks were initiated through the compression arch action stage only as the catenary action stage was not be maintained through the test. The cracking patterns are shown in Fig. 8 at the peak of compression arch action, and in Fig. 9 at failure level.

The behavior of specimen S7 was different from the preceding seismic specimens due to the existence of flanges over the span of the two-bay beam. The first main cracks occurred during the test were at the right and at the left of the interior column stub initiated at the bottom surface of the beam and propagated vertically at a load level of 39.23 kN and at a displacement of 4.65 mm. The inclined cracks were adjacent to the face of the right and the left exterior columns, and initiated at the top concrete surface at a load level of 87.73 kN and a vertical deflection of 7.49 mm. The first crack observed in the flange was recorded at a load of 45.23 kN adjacent to the interior column stub. Under further loading, concrete crushing in the bottom of the beam beside left and right columns at a maximum load level of 156.92 kN. When the displacement reached 98.07 mm, the vertical load began to decline. By the end of the test, the vertical and inclined cracks became wider and penetrated towards the compression zone, and the beam deflection dramatically increased to 152.12 mm and the test was stopped. Figures. 8.c and 9.c show the crack pattern of specimen S7.

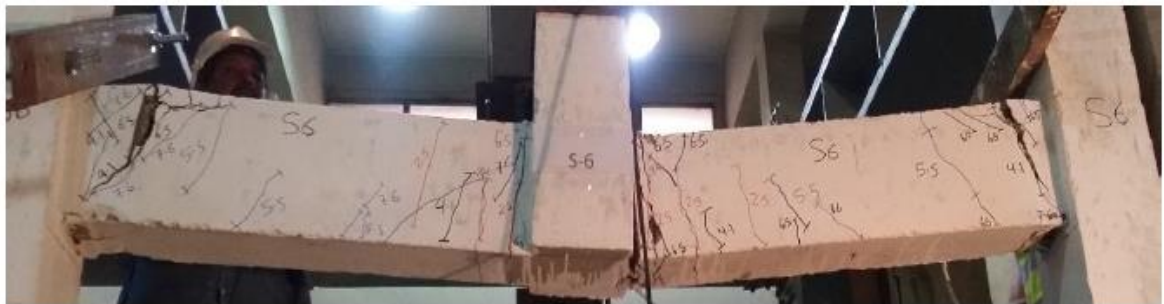
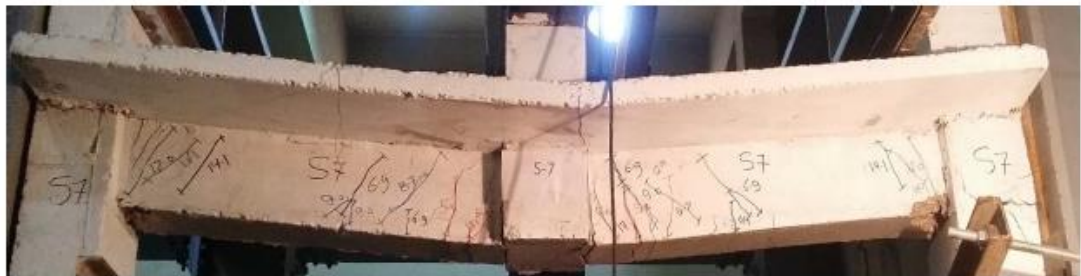
Figure 9: Crack patterns for seismic detailing specimens at failure.

For specimen S6, which reflects the effect of continuity of bottom reinforcement in the two-bay beam without any lapping. Similar to S5, severe cracks were also concentrated at the middle joint region and at the beam ends. Fig. 8.b shows that when S6 was at compression arch action stage, the first crack occurred near the interior column at a load of 30.22 kN corresponding to 3.65 mm vertical deflection. Higher load and deflections values compared with specimen S5 were obtained. Inclined cracks at the beam-column connection at the exterior columns relating to a load level of 65.14 kN with 10.69 mm deflection were developed. After reaching the peak of compression arch action at a load level of 120.91 kN, it was noticed that concrete splitting occurred in the zones of the beam assemblage subjected to excessive tensions besides the interior column and at the bottom of the beams at both ends. When the vertical deflection reached 85.51 mm the concrete crushing was observed at the middle and beam ends. Finally, at the collapse of specimen S6, the beam deflection dramatically increased to 149.10 mm and the test was stopped as shown in Fig. 9. b.

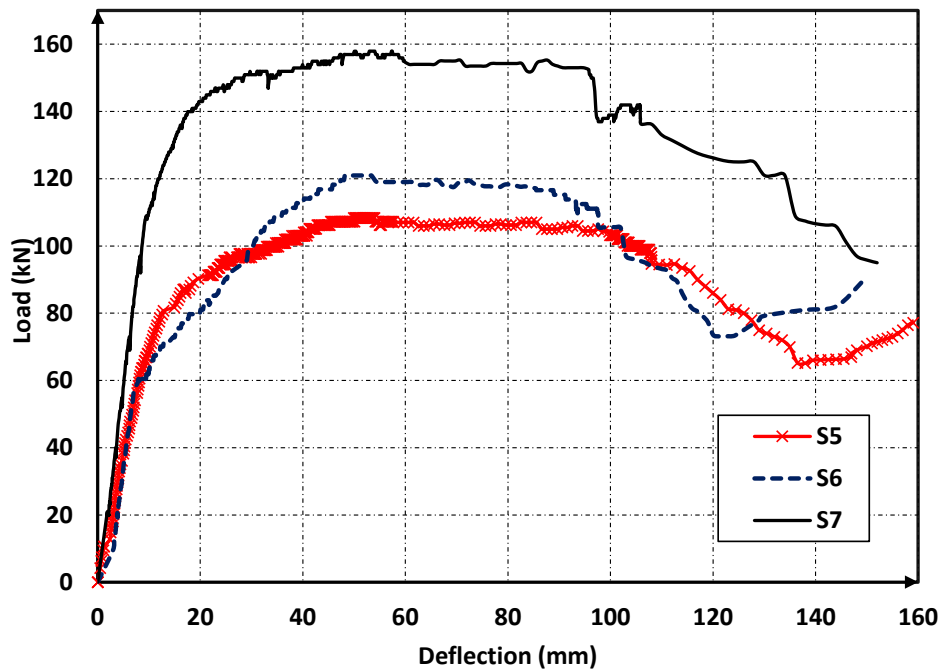
Figure 11: Load-deflection curves for specimen S5, S6, and S7 (specimens with seismic detailing).

For the seismic specimens, Fig. 11 shows the applied force versus downward deflection relationship of specimen S5, S6, and S7. For assemblage S5, the simulated collapse of the interior column along with the increase in the vertical deflection may be divided into four stages. The first stage can be counted as the elastic stage with initial cracking force P_{crs} of 26.81 kN and a displacement Δ_{crs} of 3.35 mm. The second stage is the onset of the inelastic behaviour. The yield load P_y 85.81 kN was achieved at a deflection Δ_y of 17.19 mm. It is observed that most of the reinforcement bars yielded at the mid-span of the two-bay beam and then at the exterior columns, indicating the formation of plastic hinges at the end of this stage. Stage three is the end of the compression arch action stage where the vertical displacement increases to 50.49 mm and S5 attained the ultimate resistant capability P_u 108.32 kN. Specimen S5 peak capacity was almost remained constant up to a displacement level of 98.23 mm. The deformations are governed by plastic rotations of the beam ends and severe concrete crushing was observed as the vertical displacement increased. The peak capacity dropped by 25 % when the displacement Δ_{nf} reached 138.23 mm. Catenary action stage was not achieved at the test as the limitations of LVDT deflections. The load resistance was decreasing slowly with increasing displacement until the final displacement Δ_f reached 146.96 mm corresponding to a final collapse load P_f of 64.51 kN.

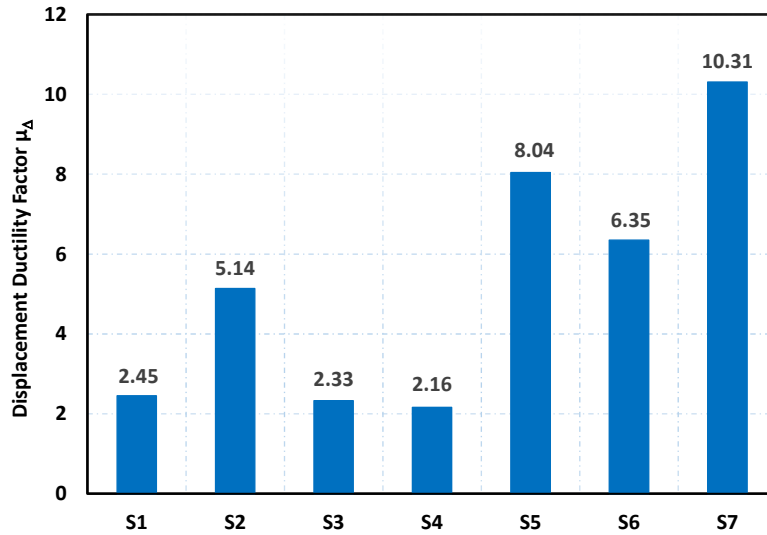
Figure 12: Displacement ductility factor (μ_{Δ}) of the tested assemblages.

Figure 12 and Table 4 outline the displacement ductility factors μ_{Δ} of the tested beam-column assemblages. For the non-seismic specimens, the ductility factors of S1, S2, S3, and S4 are 2.45, 5.14, 2.33, and 2.16 respectively. S2 ductility level is increased by 110% compared with that of S1 due to the contribution of concrete flanges attached to the assemblage all over the span. For specimen S3, the ductility level is almost the same compared with S1 due to the same tension bottom reinforcement configuration. For assemblage S4, the ductility factor is decreased by 11.8% compared with S1 due to the increase in bottom reinforcement ratio which leads to delay the yielding displacement of tension reinforcement.

For the seismic specimens, the ductility factors of S5, S6, and S7 are 8.04, 6.35, and 10.31 respectively. S7 ductility level is increased by 28.23 % compared with that of specimens S5 due to the influence of concrete flanges attached to the specimen. For assemblage S6, the ductility factor is decreased by 21.1 % compared with that of S5 due to the continuity of bottom reinforcement. In order to investigate the effect of seismic detailing on the displacement ductility factor of the beam-column assemblages, non-seismic specimens S1 and S2 were compared to seismic detailing assemblages S5 and S7. The ductility factor is significantly enhanced by using the seismic detailing provisions. The displacement ductility factor is increased to 3.28 and 2.01 times for assemblages S5 and S7, respectively, compared with S1 and S2.

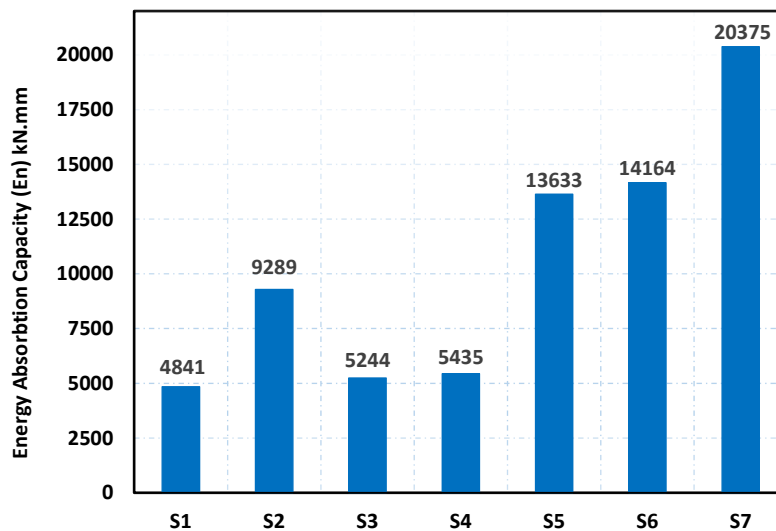
Figure 13: Energy absorption capacity (E_n) of the tested assemblages.

Figure 13 presents the capacity of the absorbed energy of the tested specimens. For the non-seismic specimens, the over-all energy dissipated for specimens S1, S2, S3 and S4 are 4.8 kN.m, 9.2 kN.m, 5.2 kN.m, and 5.4 kN.m respectively, at the end of each test. For assemblage S2, the energy dissipation capacity is increased by 91 % compared with that of S1 due to the existence of concrete flanges. For S3 and S4, the energy dissipation capacity is increased slightly by 8.30 % and 12.30 % compared with S1 due to the increase in the top and bottom reinforcement ratios. The total energy absorbed for seismic assemblages S5, S6 and S7 are 13.6 kN.m, 14.1 kN.m, and 20.3 kN.m respectively, at the end of each investigation. For specimen S7, the energy absorption ability is increased by 49.5 % compared with that of S5 due to the effect of concrete flanges. For assemblage S6, the energy dissipation capacity is increased by 3.90 % compared with S5 due to the effect of bottom reinforcement continuity without lapping at beam mid-span. The energy absorption ability is considerably improved by utilizing the seismic detailing provisions. The energy absorption factor increased by 2.83 and 2.21 times for assemblages S5 and S7, respectively compared with the non-seismic assemblages S1 and S2. Therefore, appropriate internal energy dissipation is supplied through enough ductility, continuity of rebars, seismic detailing provisions, and redundancy which leads to decrease the progressive collapse damage to the structures.
